# Sleuthing the Mundane and the Catastrophic

**FORENSIC ARCHITECTS AND ENGINEERS EMPLOY INVESTIGATIVE TECHNIQUES, NOT TO POINT FINGERS, BUT TO FIND THE ROOT CAUSE AND RECOMMEND SOLUTIONS FOR PROBLEMS THAT PLAGUE BUILDINGS**

By Joann Gonchar, AIA

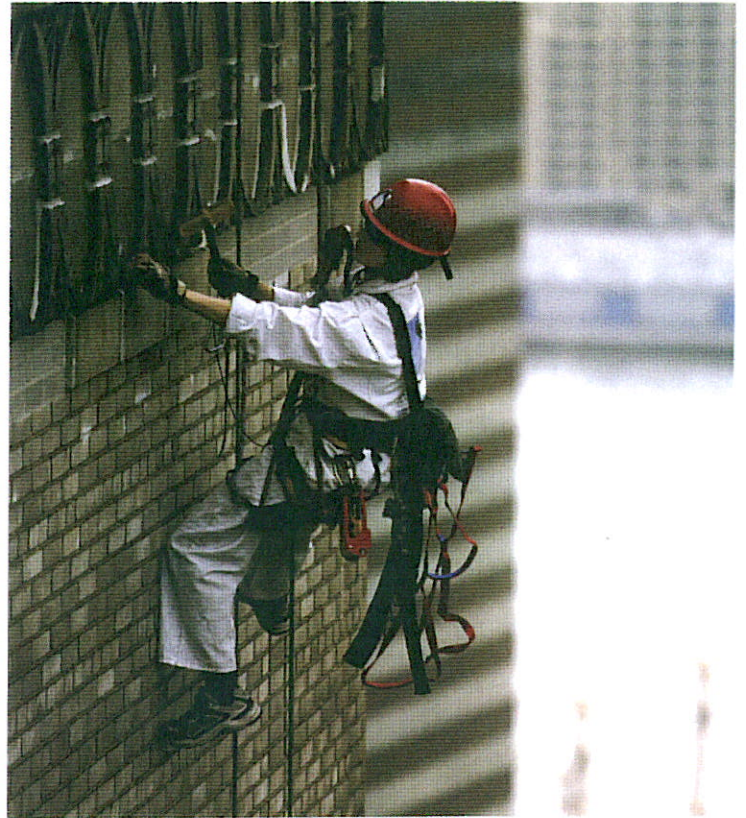
A surveyor, suspended by a two-rope system similar to that used by climbers, evaluates and documents facade conditions of a historic building.

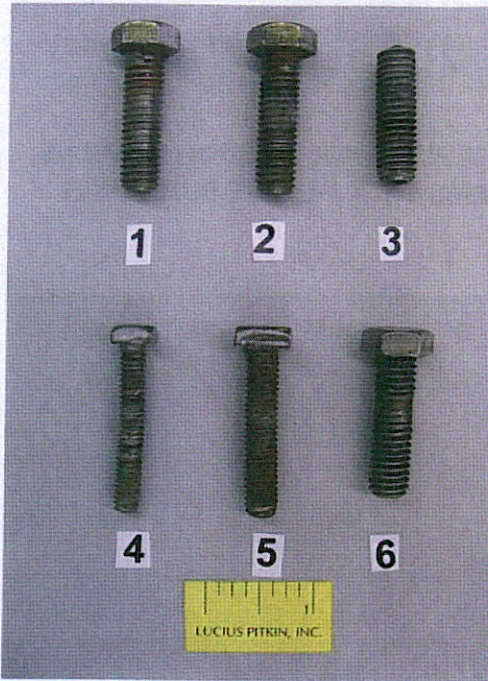
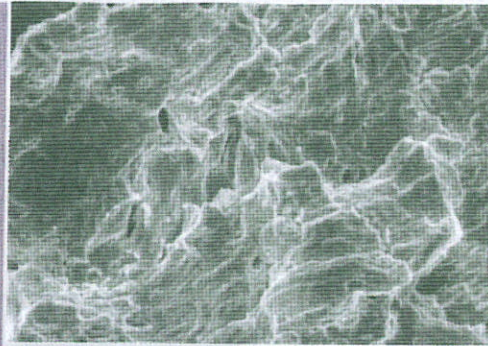
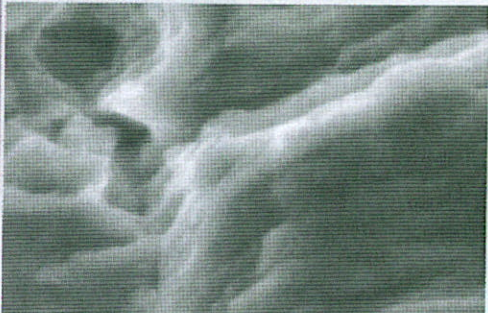
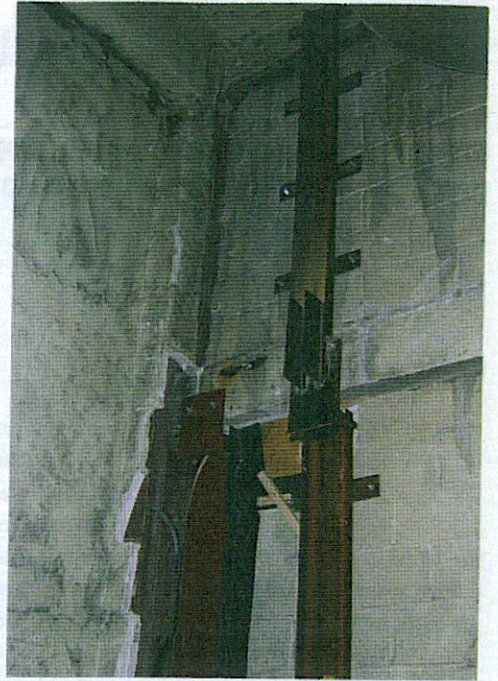
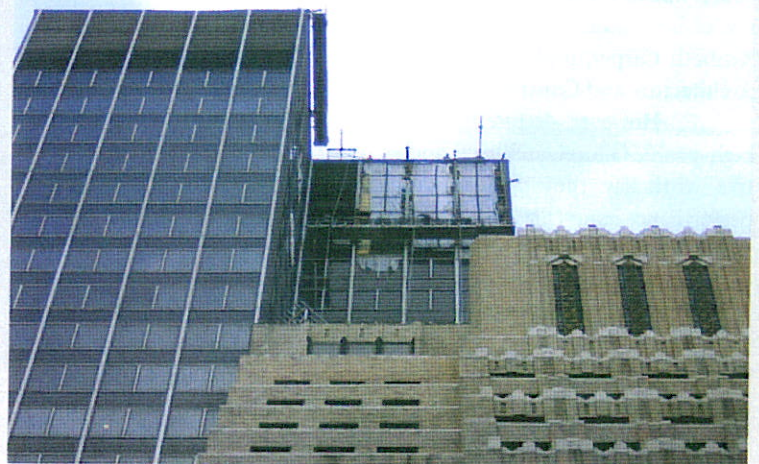
After a portion of louvered curtain wall fell from the upper floors of a Midtown Manhattan office tower (right), investigators braced a concrete masonry wall (above far right) and stabilized other surrounding construction. Debris was

cataloged (above) and tested. Magnification of the surface of a fractured bolt revealed a pattern of failure consistent with fatigue (two images, above middle). But this bolt was not ultimately considered to have played a role in the collapse.

says. Although it showed no signs of impending failure, engineers devised shoring from steel angles and channels that the contractor had on hand. In addition, the outside face of these walls was covered with plywood.

Concurrent with the examination of the mullion-spandrel connections, Thornton Tomasetti was also trying to determine what made the louvered section that fell during the February snowstorm particularly vulnerable. Using methods not so different from those employed by plane-crash investigators, the team cataloged the recovered debris and reconstructed the facade in a vacant retail space on the building's ground floor.

One bolt with a missing head was recovered. Its surface, magnified 7,500 times, revealed a pattern of parallel bands—an indication of failure due to fatigue, explains Vecchio. But the Thornton Tomasetti team

could not link the bolt directly to the failed area and theorized that it may even have been a stray bolt broken during construction.

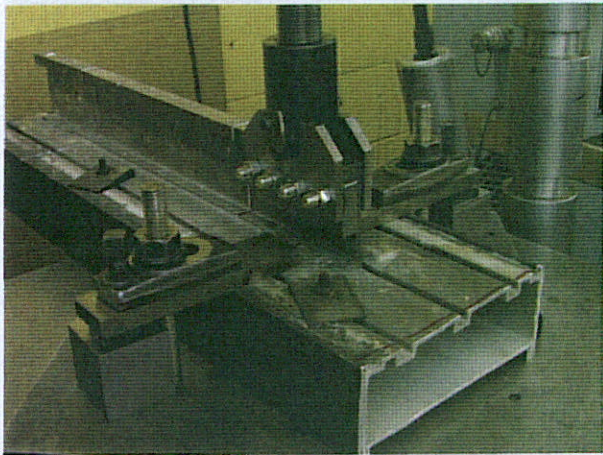
LPI tested a portion of recovered mullion (below) from the Midtown Manhattan office building's failed section of curtain wall to determine the load-carrying capacity of the weld holding the clip to the mullion. However, no deficiencies were found.

welds attaching the connection plates to the mullions, but no deficiencies were found. LPI also examined other recovered components, including the bolts used to secure the curtain wall to the building's structural frame. The majority of recovered bolts showed evidence of damage from wind loading. "The bolts had moved back and forth [within the clips and connection plates] to the point of rubbing off the threads," says Mancini.
