## Fiber Optic Investigation: The See Snake

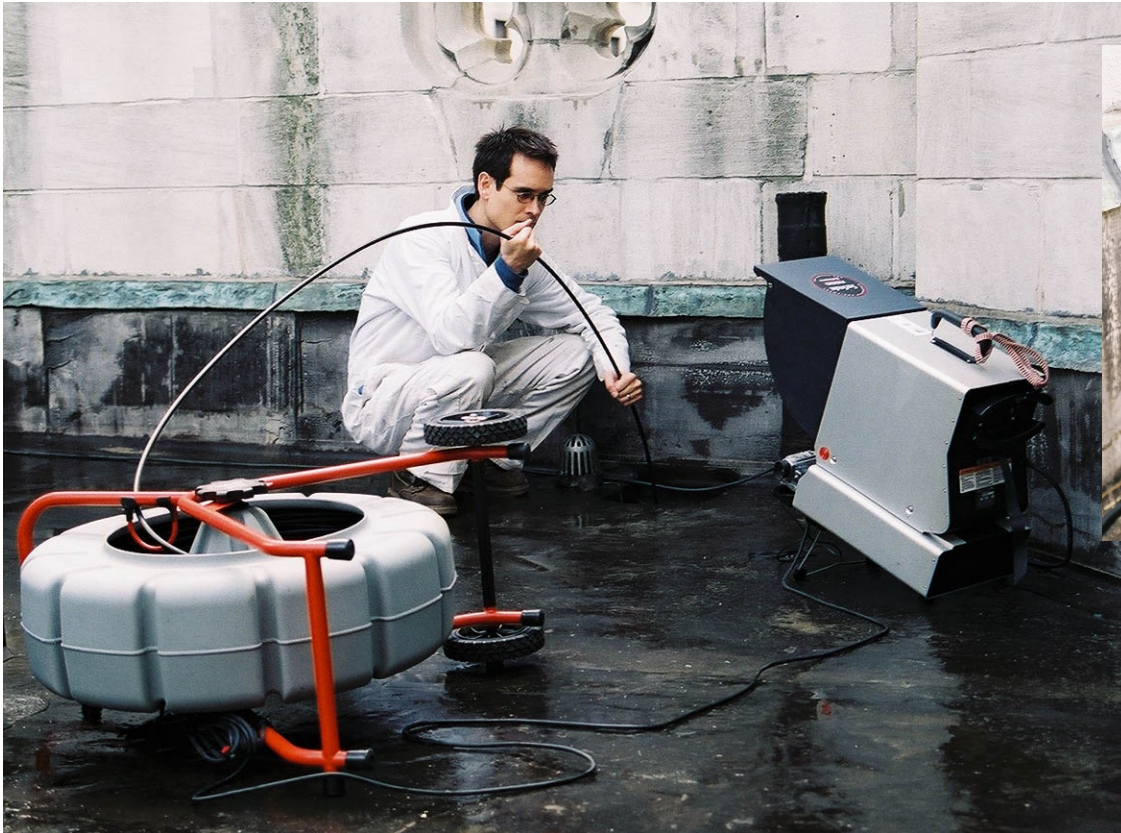
*Vertical cracks in an internal cast iron roof leader were identified using the See Snake.*

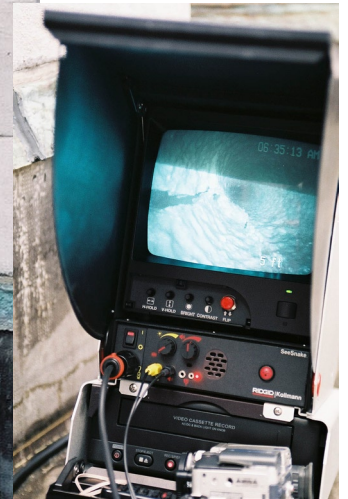
*Fiber-optic investigation of a drain pipe embedded within a masonry wall at St. Thomas Church in New York City.*

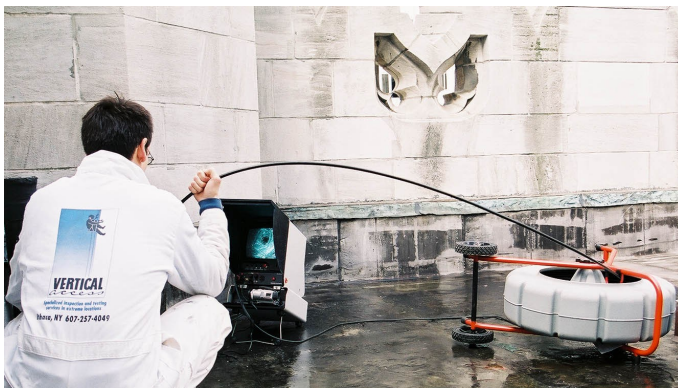
*A portable monitor allows the investigation to be viewed live while a VCR records the video feed and narration made on site.*

The See Snake has a portable monitor and VCR that is utilized on site for viewing and recording the video feed and operator’s narration. The See Snake can be used to investigate pipes 2 to 8 inches in diameter and can navigate horizontal and vertical surfaces as well as difficult 90° bends, diagonal runs, and connections.
